# Refractory and Engineering Technology on Glass Melting Furnace

AGC Ceramics Co.,Ltd  
Shinji Yamamura

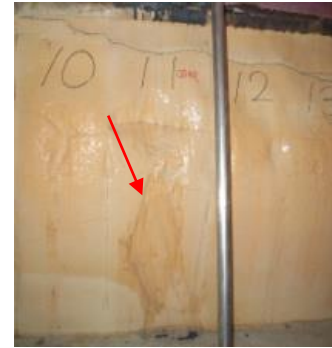
Unusual heavy corrosion of side wall  
due to internal void, which was  
manufactured before 1990.

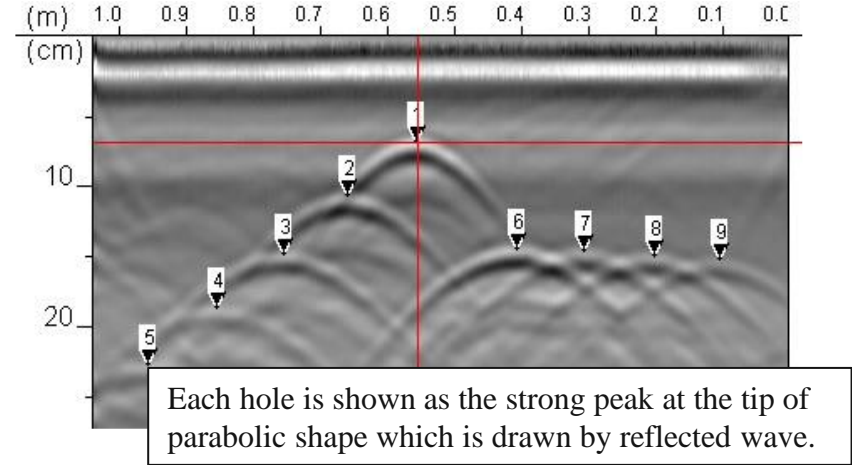
All holes can be measured at the tip of parabolic shape correctly.  
Based on this theory, non destructive internal inspection has been developed in 1991, and as one of our quality assurances before shipping, we have carried out this inspection for all important large blocks since 1992.<sup>1)</sup>

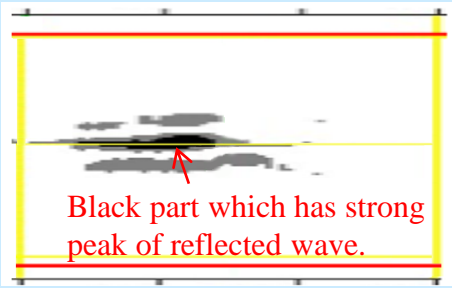
<p>A radar scan image of Sample-A. A black, irregularly shaped area in the center is highlighted by a red arrow. The text 'Black part which has strong peak of reflected wave.' is written in red below the arrow.</p>

Sample-A (Rejected)	Sample-B (Good)
<p>The result of non destructive inspection.</p>

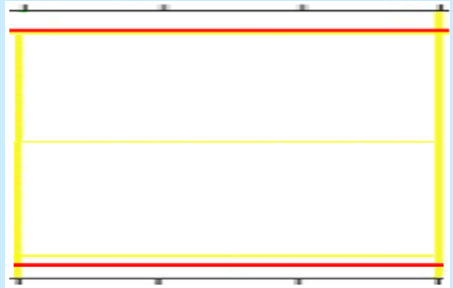
<p>A radar scan image of Sample-B, showing a clean, uniform white surface with no significant reflections or voids.</p>
<p>Confirmation of the cross section after cutting</p>

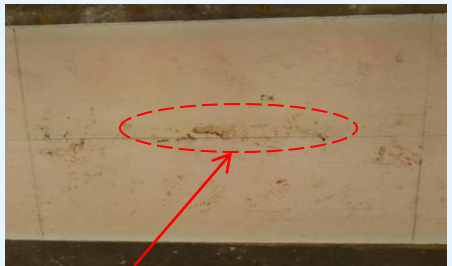
<p>A photograph of the cross-section of Sample-A. A red dashed oval highlights a dark, irregularly shaped area in the center, which is the internal void. A red arrow points to this area.</p>

Internal void at the center of cross section

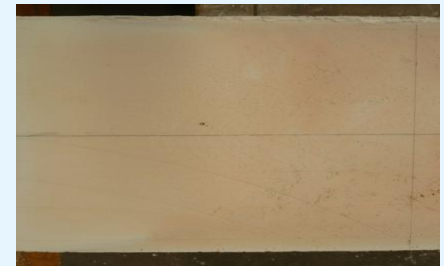
<p>A photograph of the cross-section of Sample-B, showing a uniform, light-colored surface with no visible voids or defects.</p>

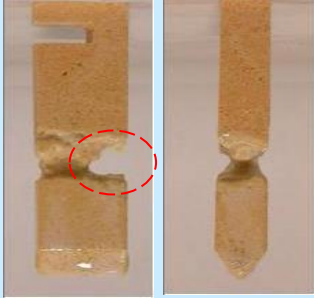
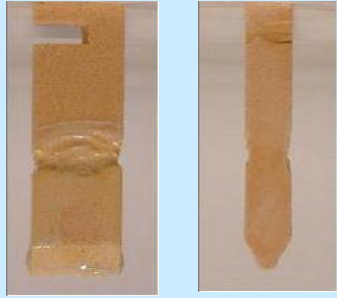
Sample-A (Rejected)	Sample-B (Good)
<p>TC-11 corrosion test</p>

Corrosion test in laboratory.

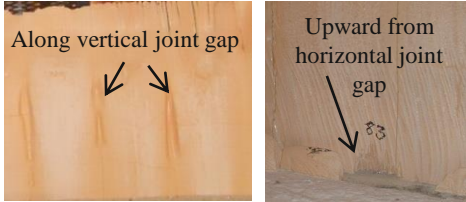
<p>Along vertical joint gap</p> <p>Upward from horizontal joint gap</p>	These corrosions may be influenced by condition of joint gap and design concept.
3) Unusual corrosion without joint gap and clear crack.

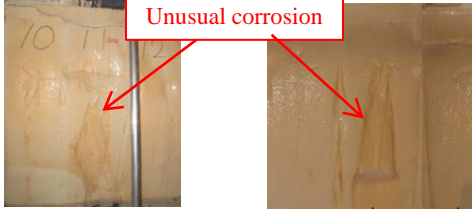
<p>Unusual corrosion</p>	Internal defects may influence these type of unusual corrosion .
