# GLASS: INSPIRING NEW FRONTIERS OF DEVELOPMENT

## SmartMelter: New Industry Standard in Furnace Life Optimization

Dr. Yakup Bayram, Fred Aker, Elmer Sperry  
AFGM 2019

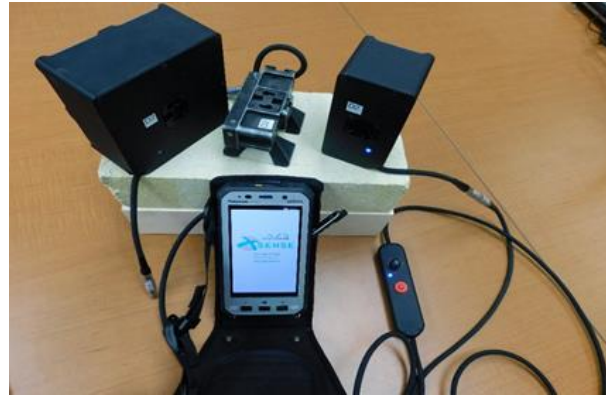
Portable Sensors

SmartMelter Technology is comprised of two key components

- Easy to use advanced radar sensors with portable and permanent versions
- Comprehensive based software for furnace health management

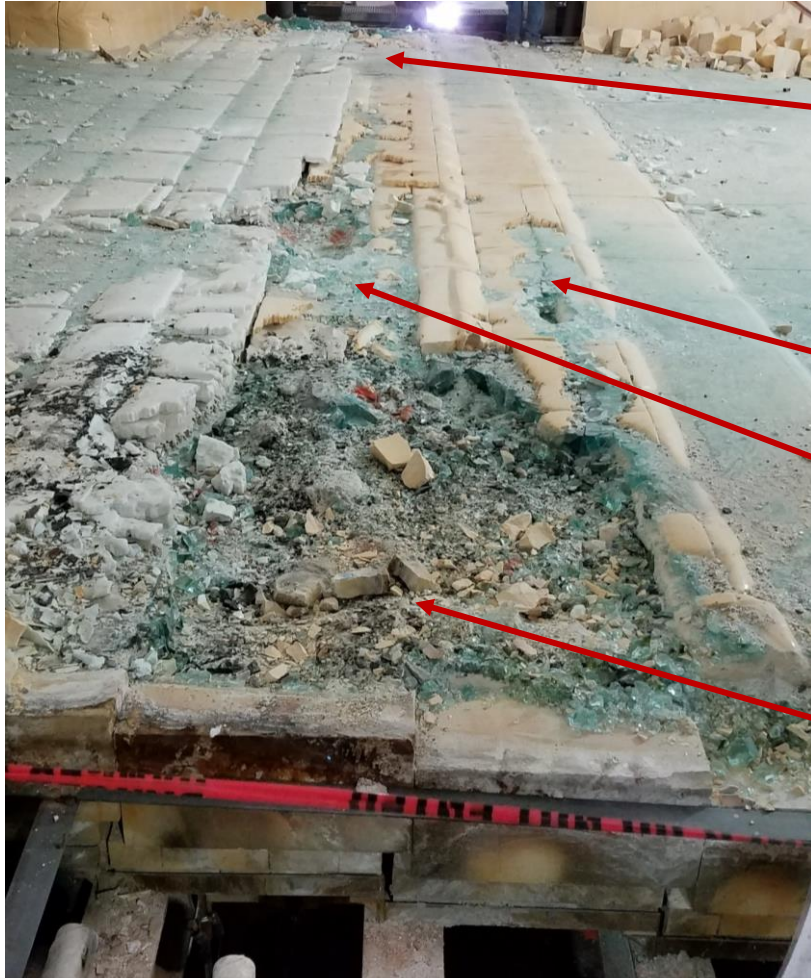
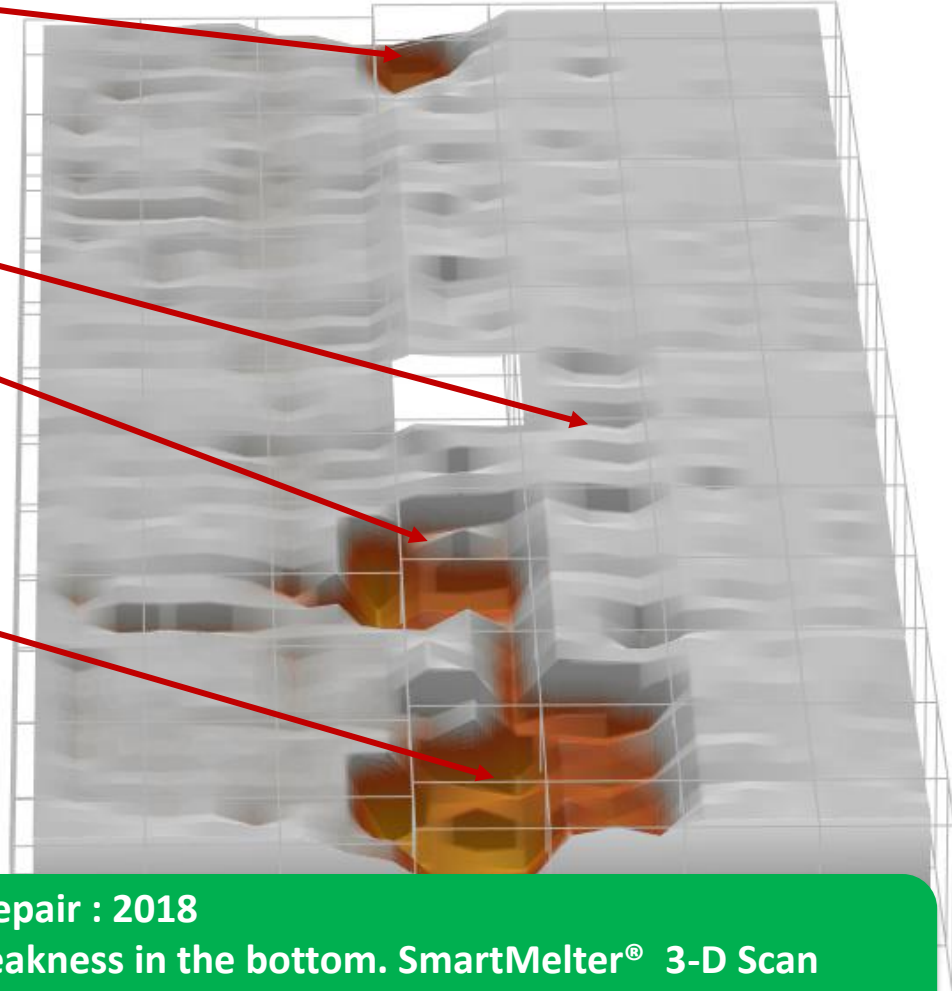
**SmartMelter® Monitoring Start Year: 2016, Cold Repair : 2018**

Customer engaged SmartMelter to identify any weakness in the bottom. SmartMelter® 3-D Scan indicated large glass penetration in the refiner area and guided the customer for proper and effective cooling. This furnace lasted another 2 years since our first indication of glass penetration into the bottom insulation. We monitored this furnace at least every 6 months.

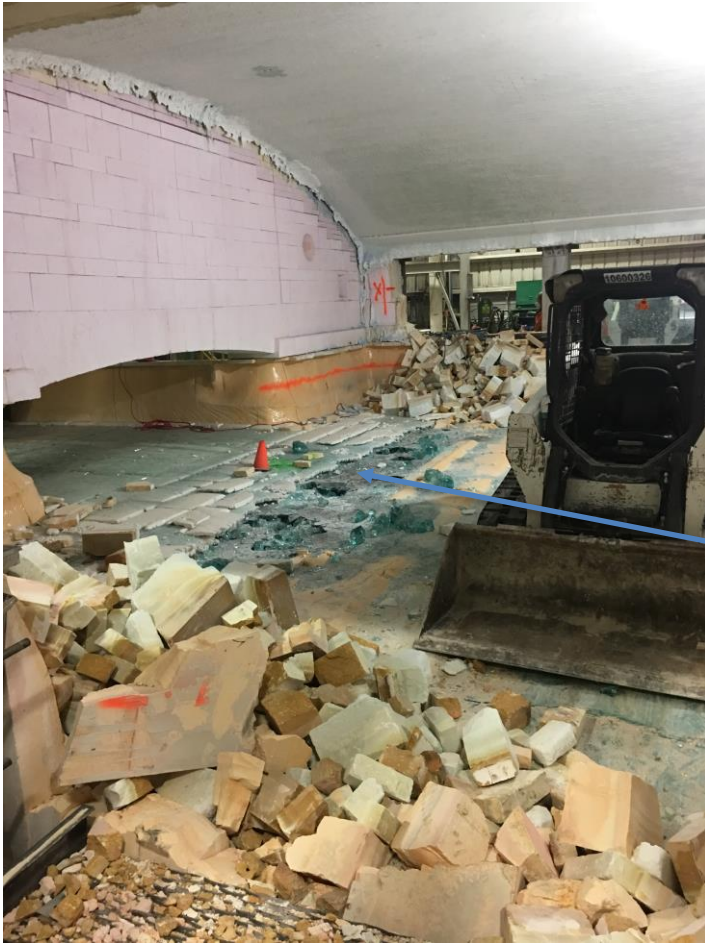
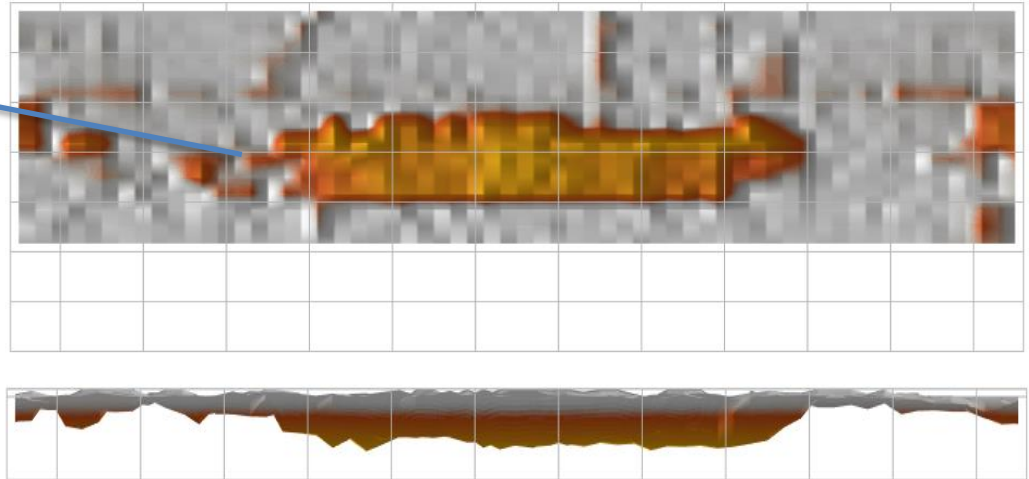
SmartMelter® Monitoring Start Year: 2017

Cold Repair : 2019

SmartMelter® 3-D Scan indicated large glass penetration with 220mm insulation left in February of 2017. We helped the customer with the proper and effective cooling. They were able to keep running the furnace two more years while the glass slowly penetrated through the insulation (Clay flux) in the bottom. We monitored this furnace at least every 6 months (sometimes 3 months) to determine the pace of erosion and assess the effectiveness of cooling

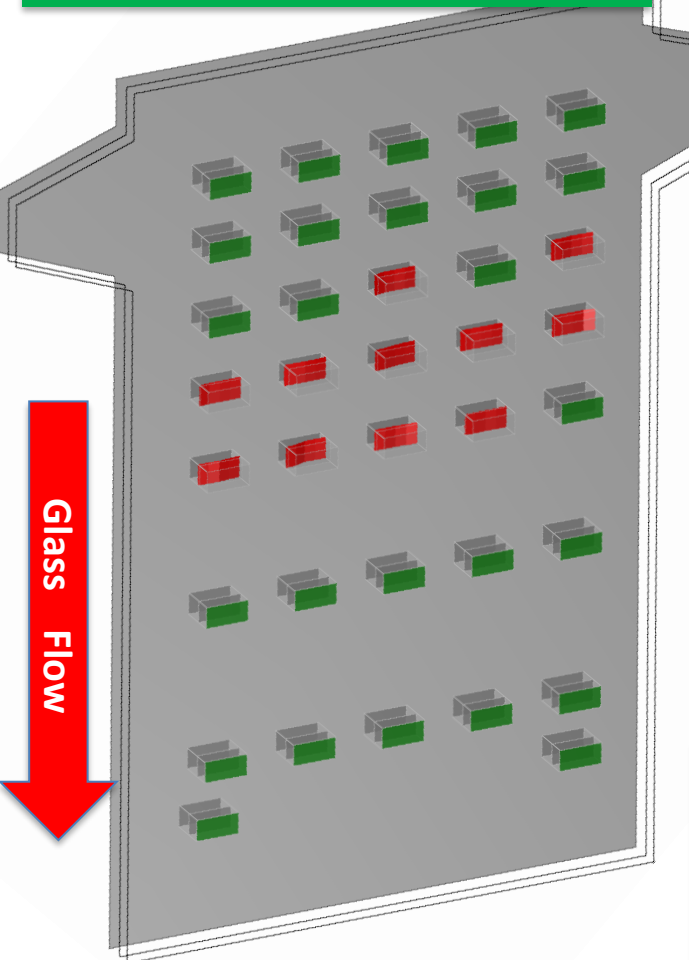
SmartMelter Inspection Map  
(4 Months Before Leak)

Post-leak photos confirmed the accuracy of the SmartMelter Inspection Report. Customer scheduled the repair too late (6 months later) despite our request for urgent action. Furnace lasted 4 months.

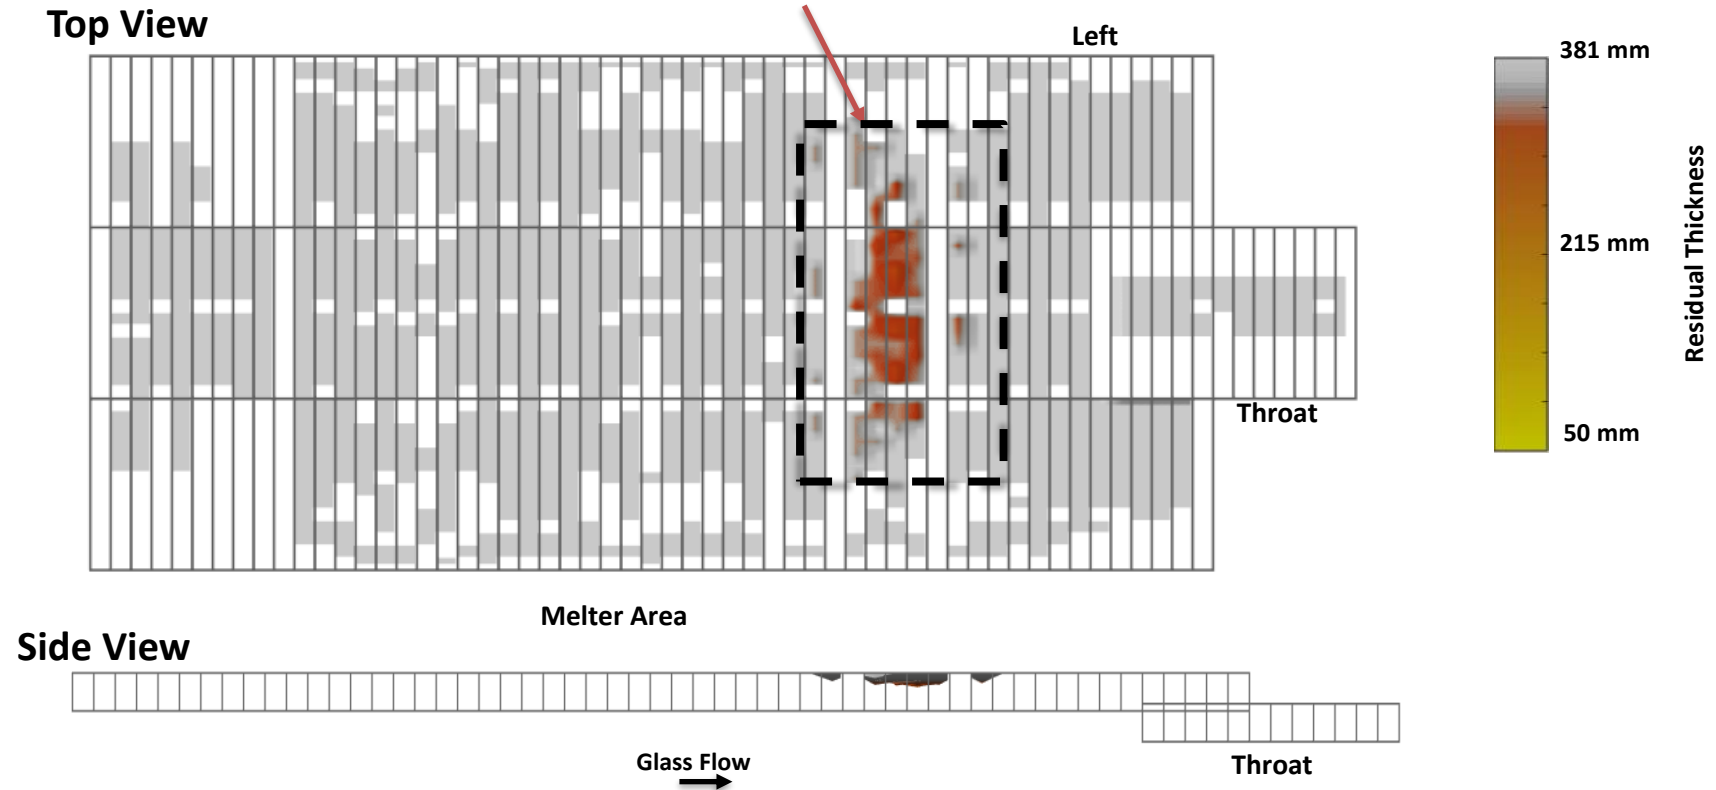
# Case Study 5: Metal + Glass Penetration in Container Bottom

SmartMelter® 3-D Scan of this furnace bottom indicated major penetration into the bottom. Customer has been working with 3 other audit/inspection firms to do thermal and visual inspection of their furnace bottom. None has indicated any issue until SmartMelter inspection. Customer drilled several spots and confirmed both metal and glass penetration into the bottom. The customer is closely monitoring the area with regular SmartMelter inspections and in the meantime working on having a hot bottom repair done.

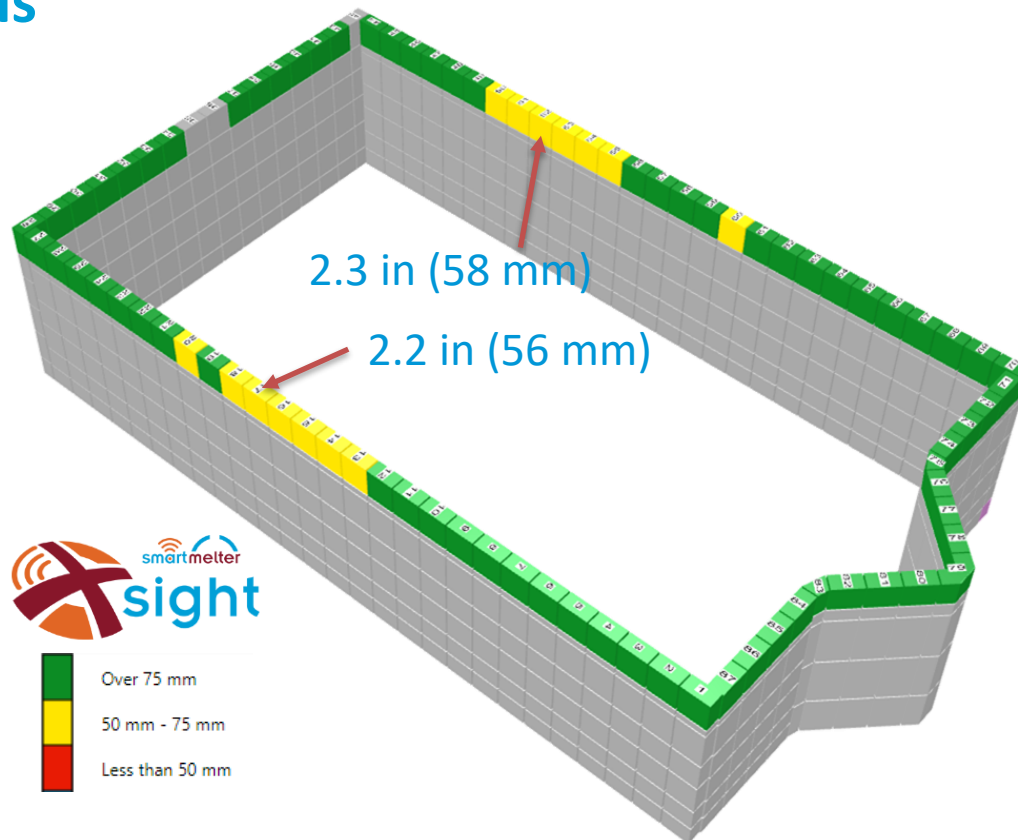
# October 2015 SmartMelter Inspection

Oct 2015 SmartMelter® Inspection: Over 50mm remaining at metal line

Overcoat delayed given the clear picture on the current state of the melter sidewalls

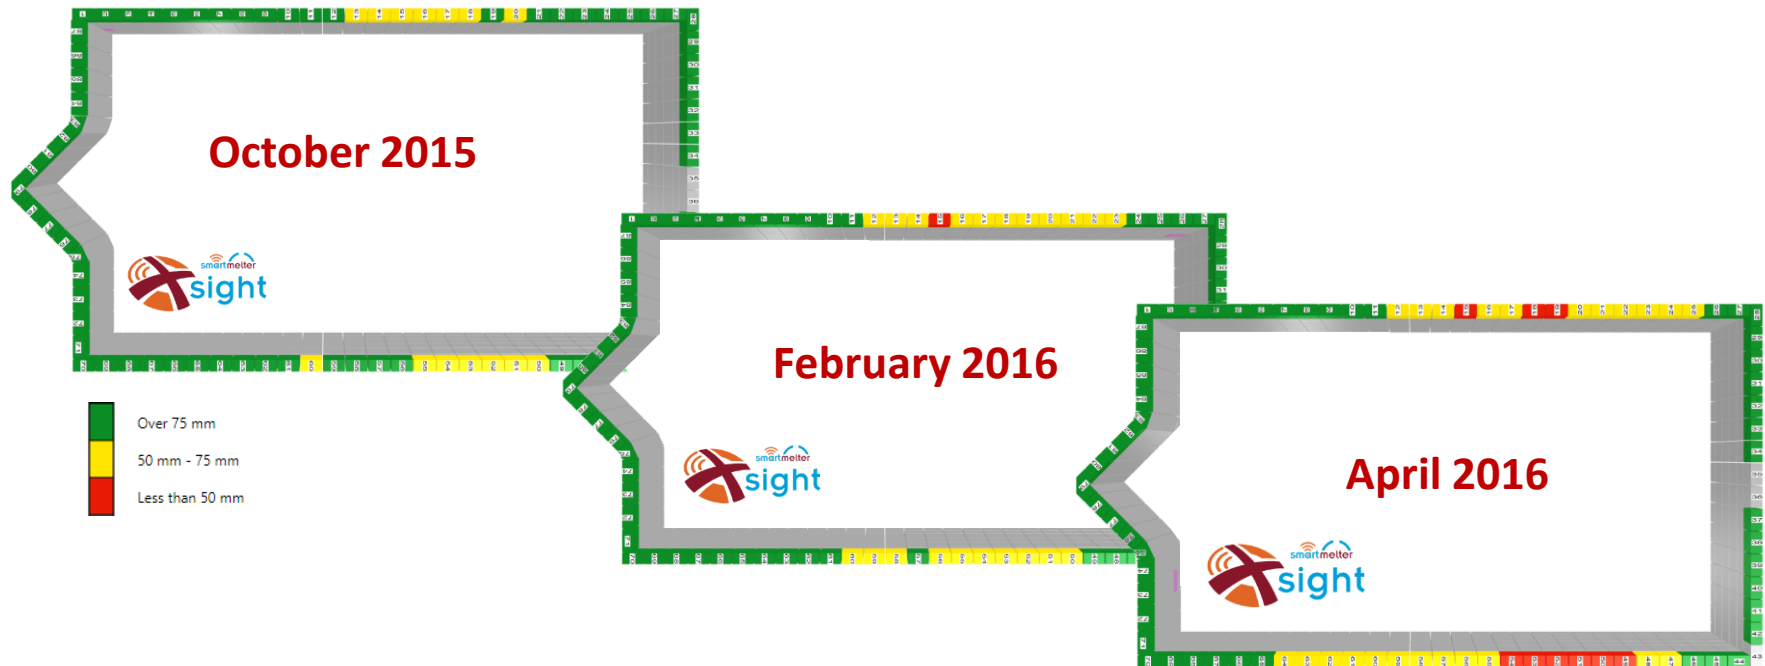
# SmartMelter Inspections, 2015-2016

Overcoat operation moved to Dec 2016: One year after original plans  
Continuous inspections of metal line thickness in 2016

Changing furnace conditions (pull, boost) over the campaign invalidated the original historical analysis

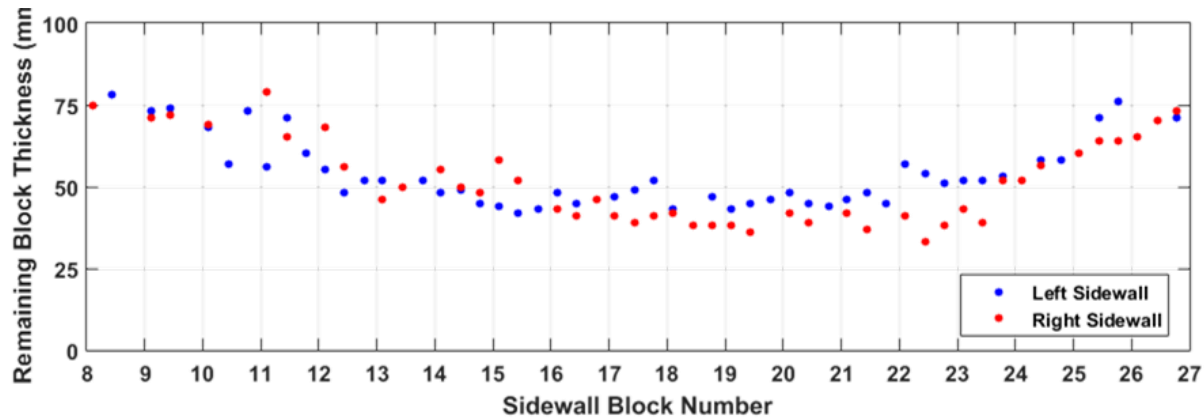
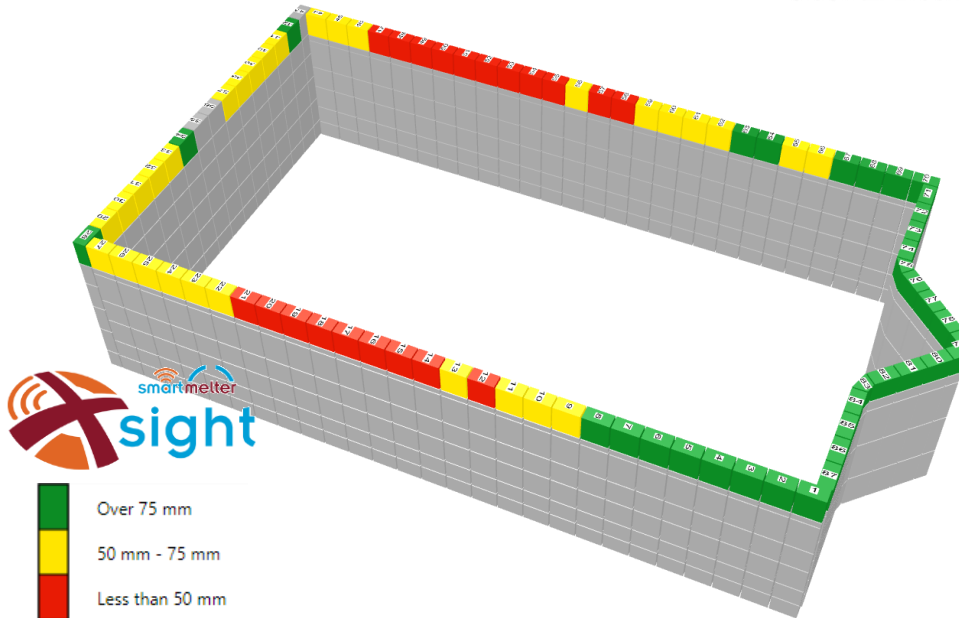
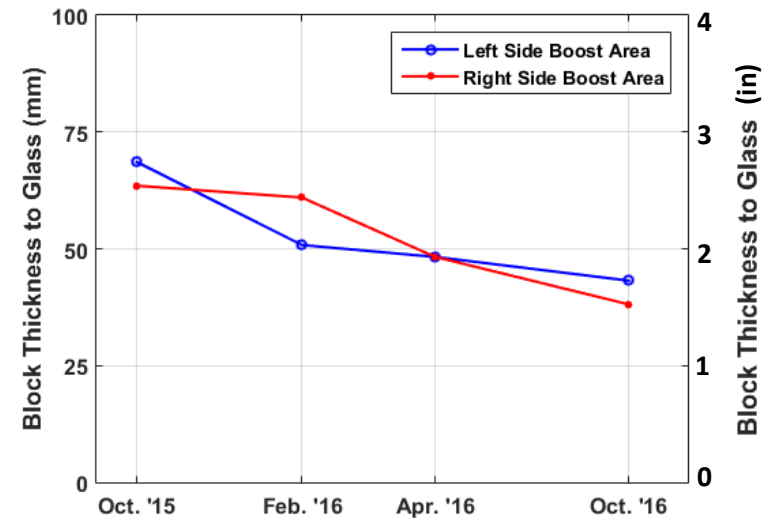
# October 2016

Last SmartMelter inspection October 2016 before overcoat

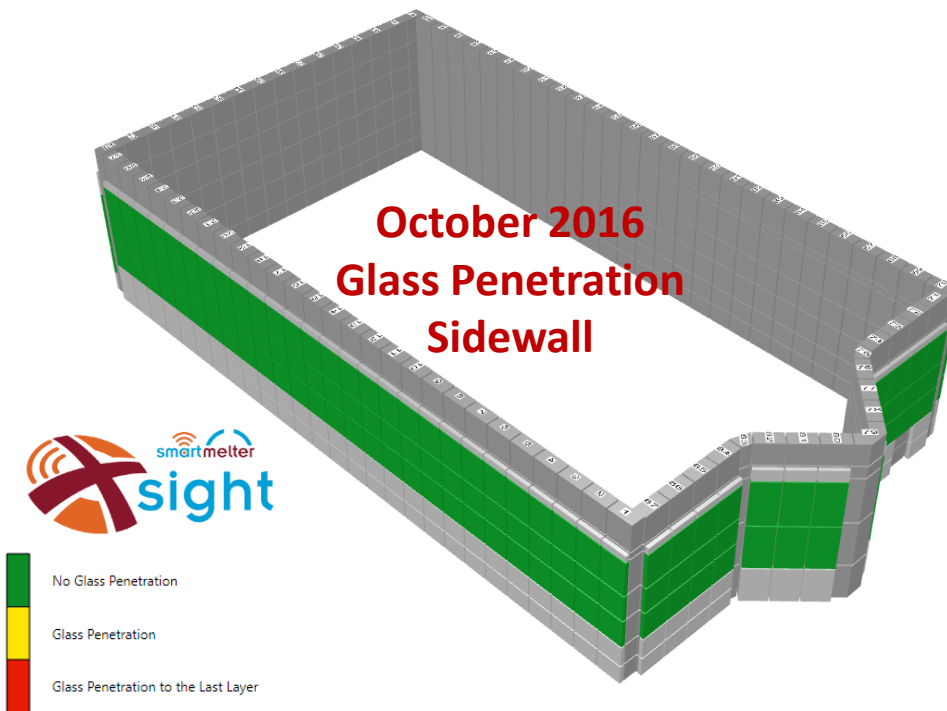
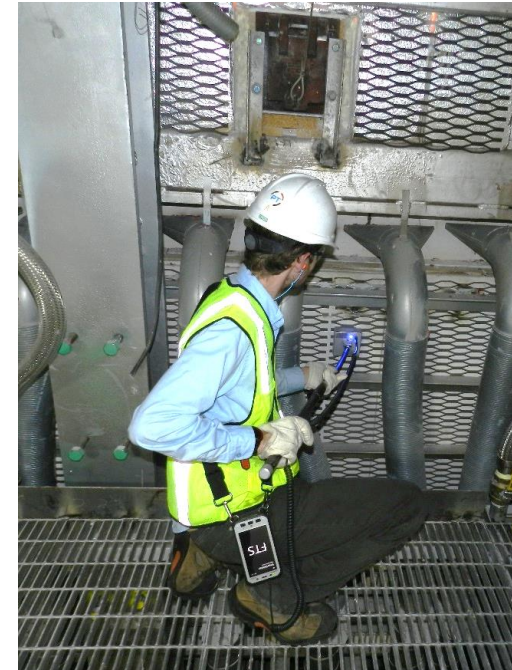
# Sidewall Insulation

Beginning in October 2016, sidewall insulation for glass penetration has been monitored in addition to the metal line AZS thickness

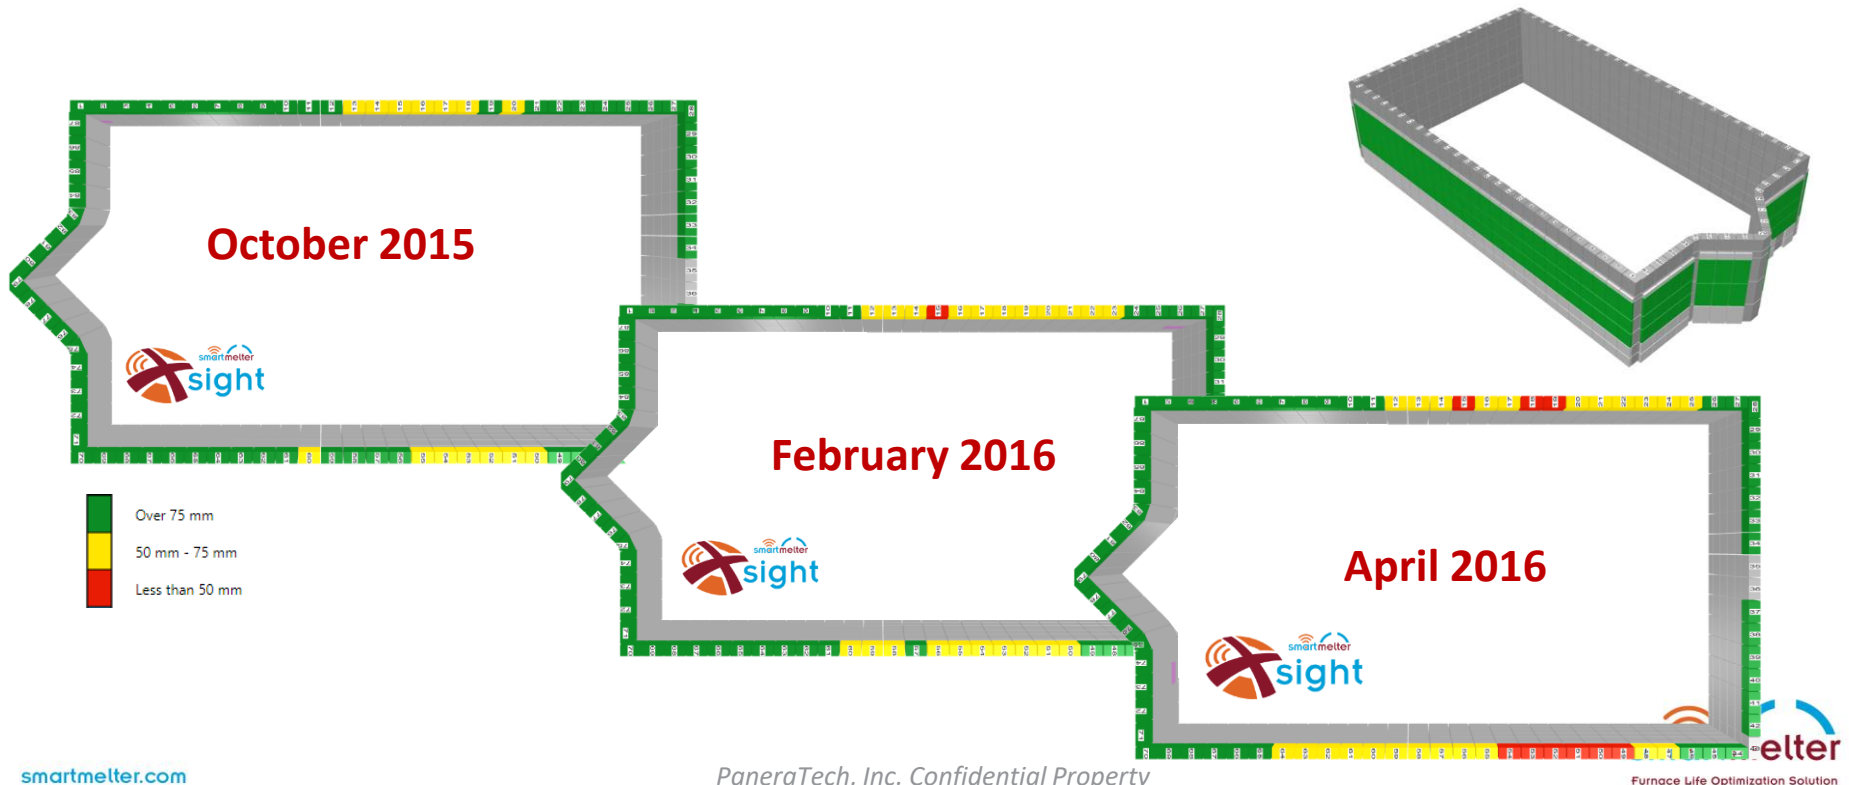
# Furnace Life Extension at Libbey Shreveport A

At the end,  
Overcoat Delayed 1 Year  
Rebuild Delayed 1.5 Year  
25% More Production than originally planned

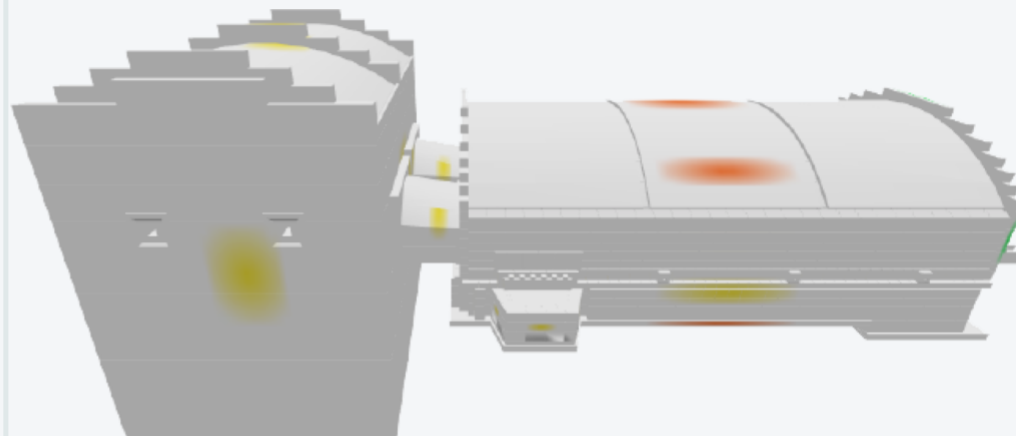
Furnace campaign started in 2012. Furnace is in good condition considering age. Process Team put great effort in keeping furnace healthy.

Major problem was detected in pressure management and control system, which has a huge impact on furnace efficiency.

Low Risk:  
Require Regular Monitoring

AREA LIST

- Bottom ★★★★★
- Crown ★★★★★
- Back part wall ★★★★★
- Left sidewall ★★★★★
- Regenerator ★★★★★
